# Inspection Report

## Sample Report

**Property Address:**  
12345 Sample Way  
San Diego , CA 12345

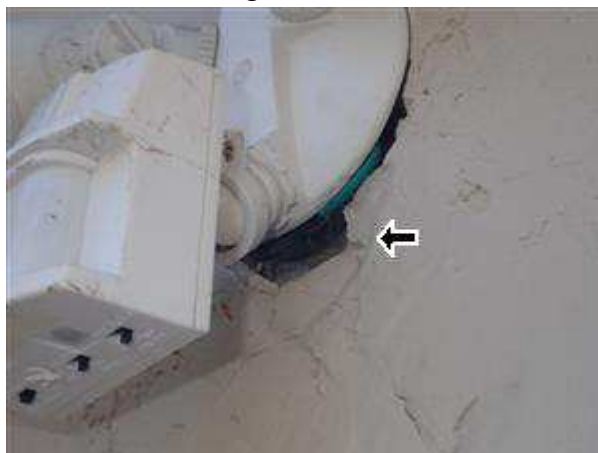
1.0 Picture 1

(1) A gap is present around a light fixture at the east side of the living room. Recommend sealing the area.

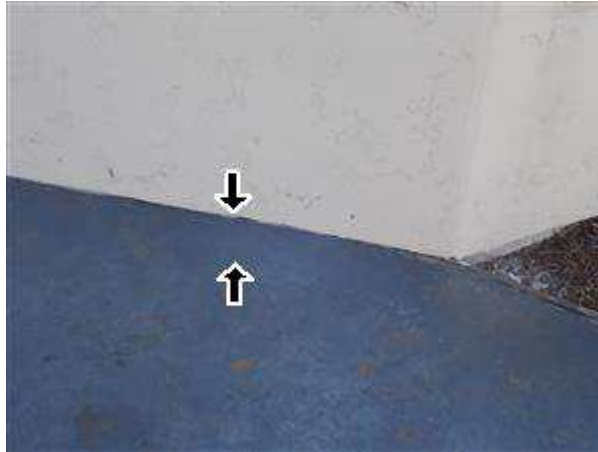
1.0 Picture 2

(2) The clearance between the weep screed and north concrete patio does not meet industry standards. The patio slopes away from the home and no visible evidence of water intrusion was observed at the time of inspection.

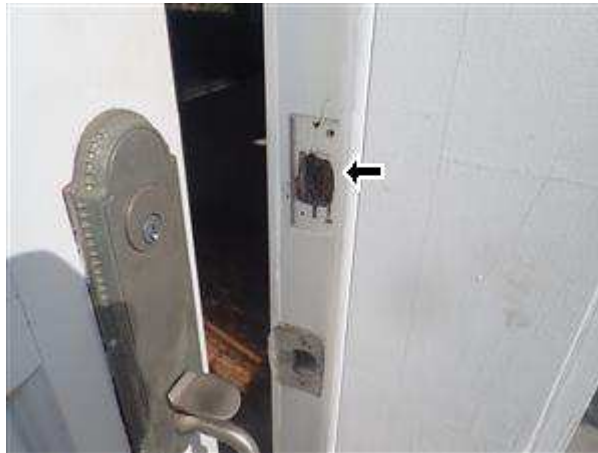
1.1 Picture 1

(1) A striker plate is missing at the main entry door. Recommend installing a striker plate for the deadbolt lock to provide added security.

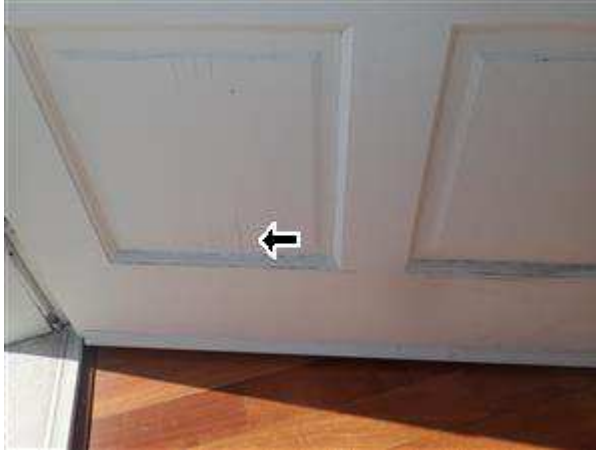
1.1 Picture 2

(2) Small cracks are present in the wood main entry door.

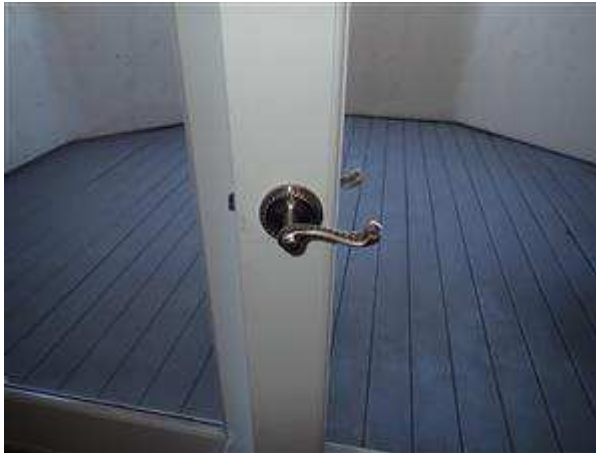
1.1 Picture 3

(3) Locking hardware is not available for the master study french doors presenting a security concern. Recommend installing locking hardware.

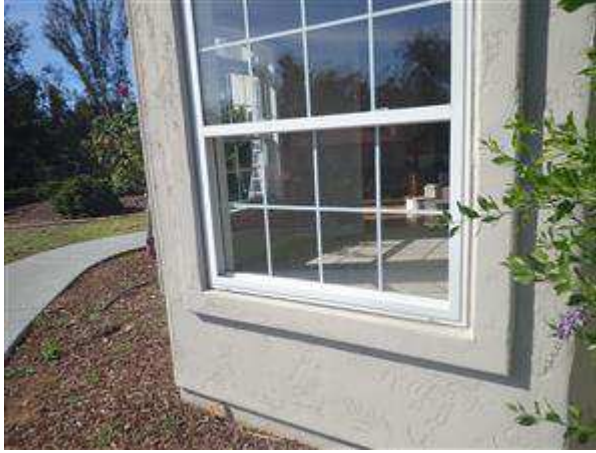
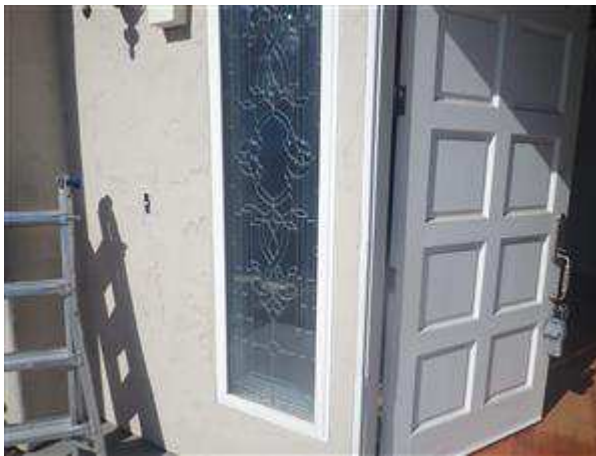
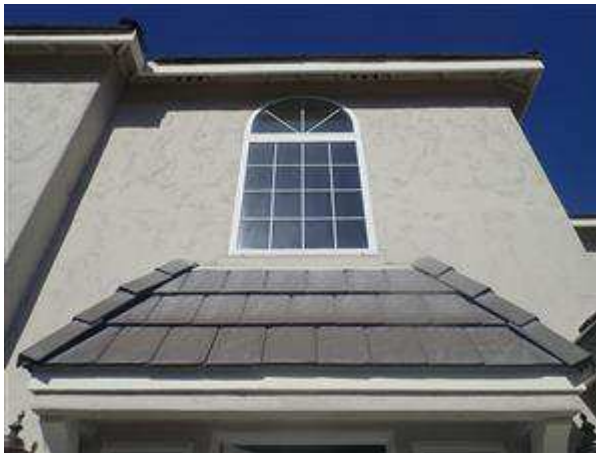
(1) Several of the dual paned windows have failed having all windows evaluated by a licensed window contractor and replace as necessary.

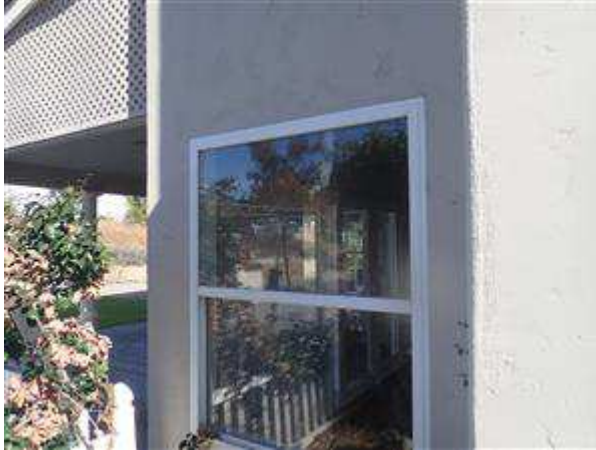
1.2 Picture 4

(2) Most of the window screens were not installed at the time of inspection. Screens were observed in the garage.

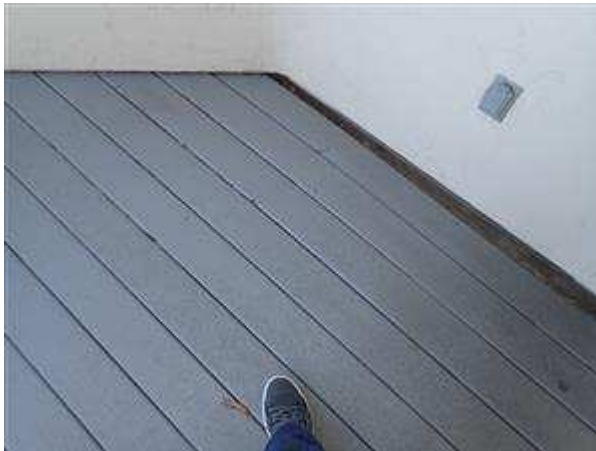
1.3 Picture 1

Some of the master deck boards are not properly secured. Recommend securing where necessary by a qualified person.

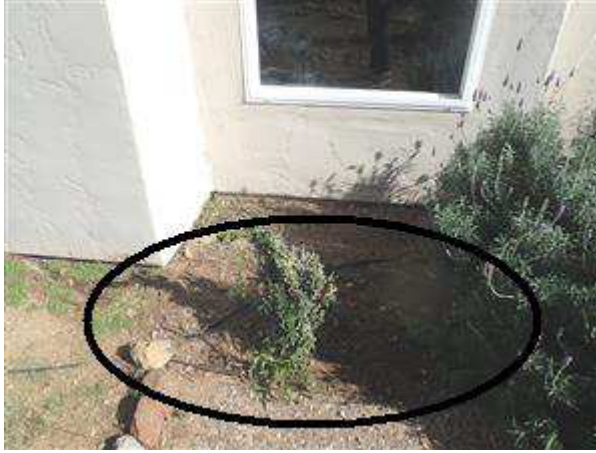
1.4 Picture 1 west side of the home

(1) Areas around the home do not maintain a negative slope from the home. Recommend maintaining a negative slope or installing a drainage system to allow water to drain away from home.

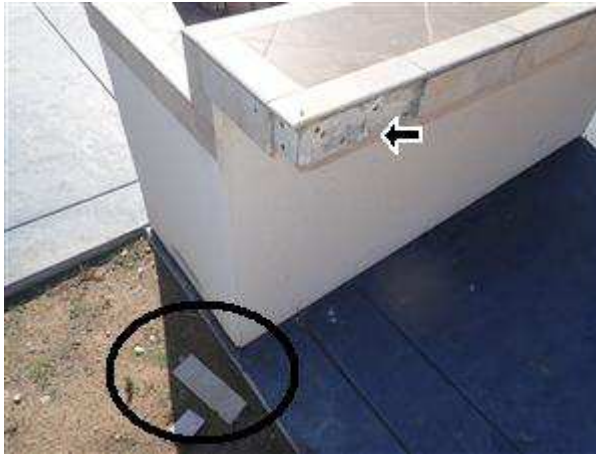
1.4 Picture 2

(2) The outdoor kitchen is beyond the scope of this inspection however some tiles have fallen off of the countertop.

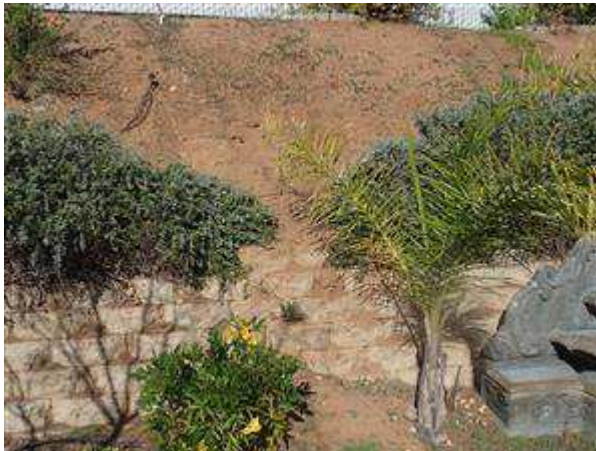
(3) Soil erosion was observed at multiple locations around the property. Recommend consulting with a landscaping contractor for options to minimize erosion.

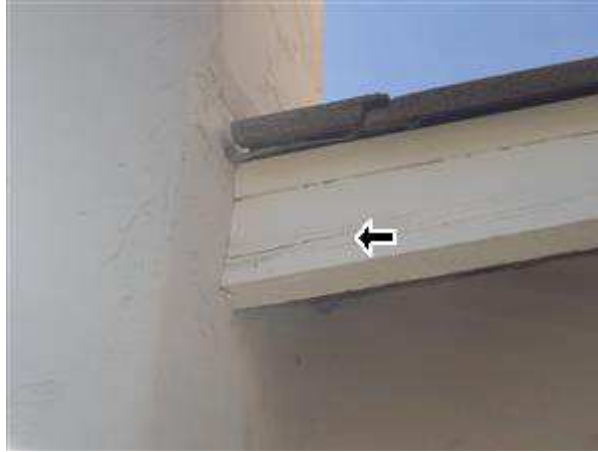
1.5 Picture 1

Deteriorated wood was observed in the fascia adjacent to the living room chimney. Recommend further evaluation from a termite inspector as well as a roofing contractor and repair or replace as necessary.

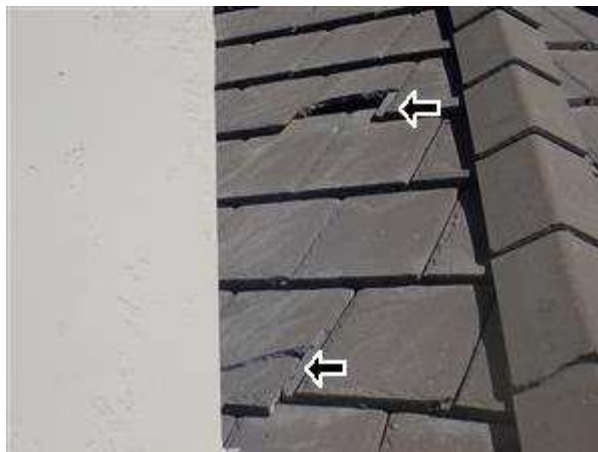
2.0 Picture 1

(1) Two damaged roof tiles were observed above the west side of the living room (right side of the main entryway). Recommend further evaluation from a licensed roofing contractor and repair or replace as necessary.

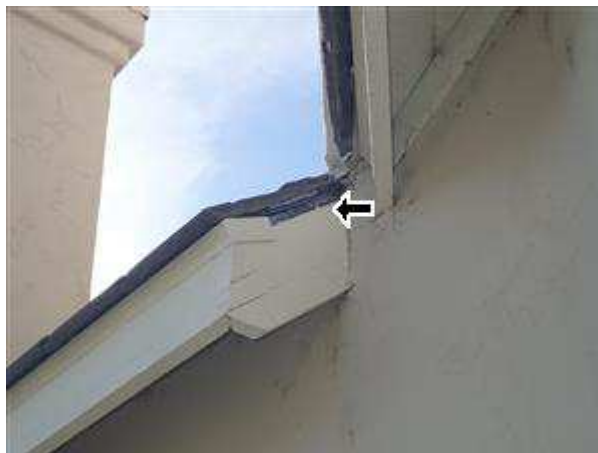
2.0 Picture 2

(2) A tile or flashing appears to be missing along a short fascia board at the east side of the living room. Recommend further evaluation from a licensed roofing contractor to determine if corrective action is necessary.

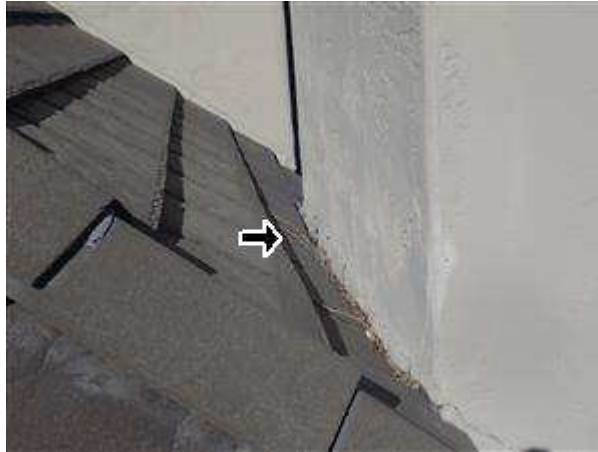
2.2 Picture 1

Cricket flashing was not installed behind the chimneys which would not meet current industry standards. Recommend further evaluation from a licensed roofing contractor to determine if corrective action is necessary.

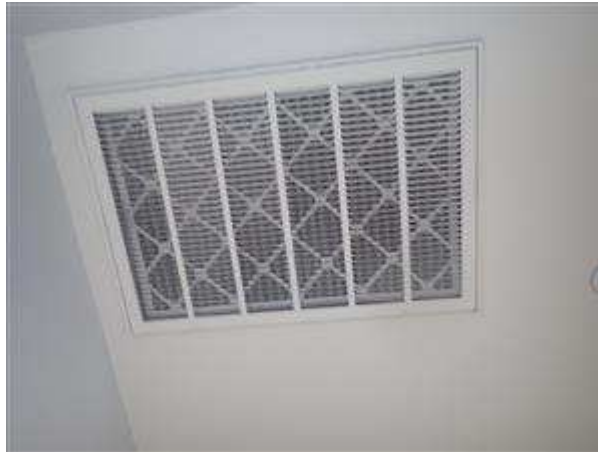
3.3 Picture 1

The air filters are dirty and should be replaced and secured before operating the heating or cooling systems.

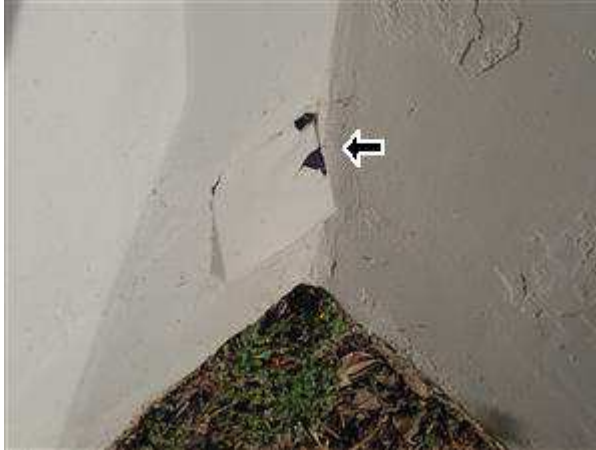
3.6 Picture 1

(1) The fireplace vent cover is damaged for the family room fireplace. Recommend replacing the cover by a qualified professional.

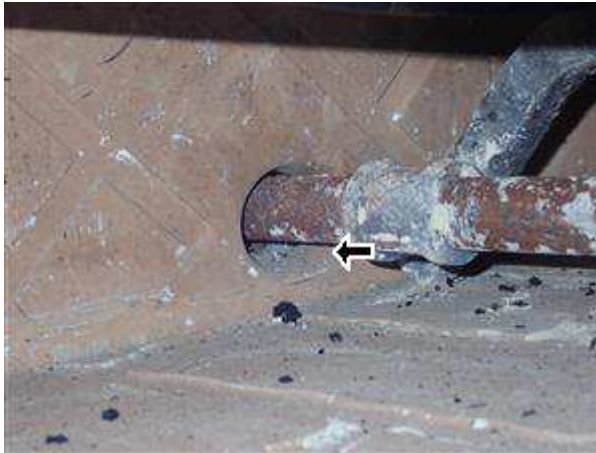
3.6 Picture 2

(2) A gap was present around the family room fireplace gas pipe. Recommend applying an appropriate fireproof material to seal the gap by a qualified person.

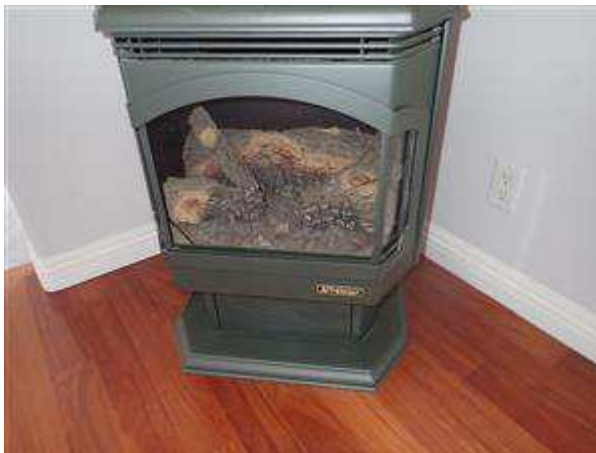
(3) The pilot light for the master study gas stove was not lit at the time of inspection. The unit was not tested by the inspector. Recommend verifying that it operates.

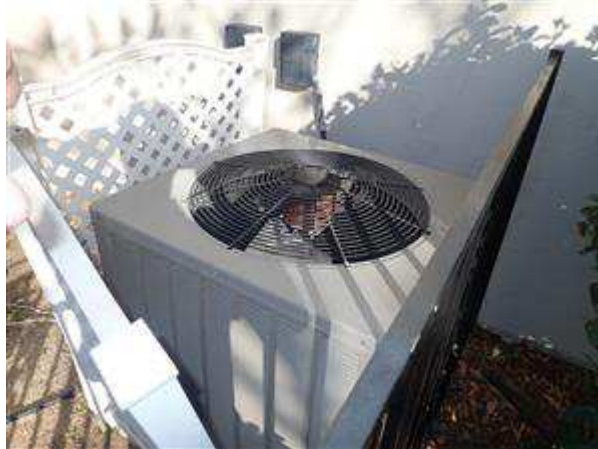
3.7 Picture 1

(1) The condensing unit did not operate when tested. Recommend further evaluation from a licensed HVAC contractor and repair or replace as necessary.

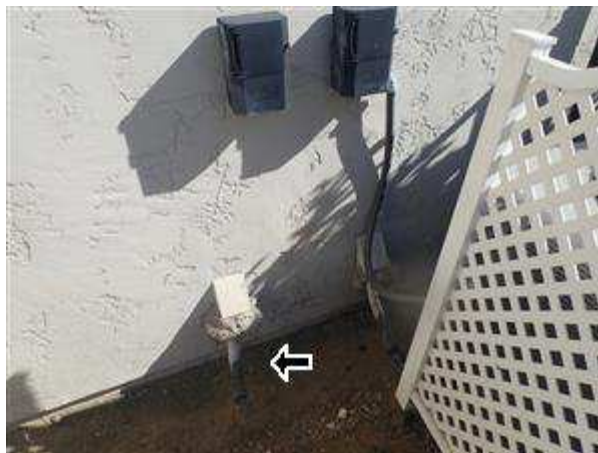
3.8 Picture 1

A condensing unit is not available for one of the zones which appears to be the upper level of the home. The home is plumbed for future A/C if desired.

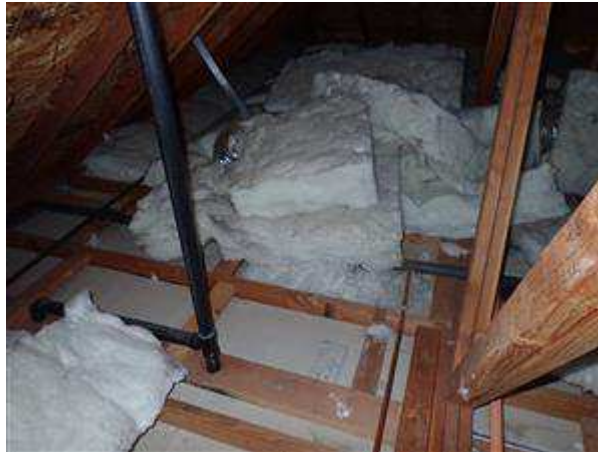
4.0 Picture 1

Some of the attic insulation was out of place. Recommend adjusting the insulation where necessary.

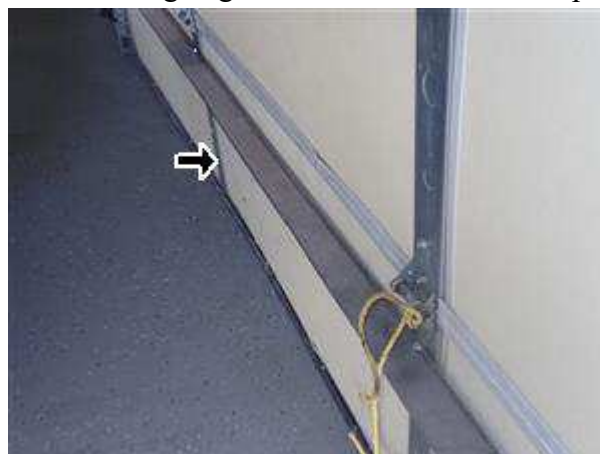
6.3 Picture 1

The two car garage door is bent. The door opened and closed properly when tested.

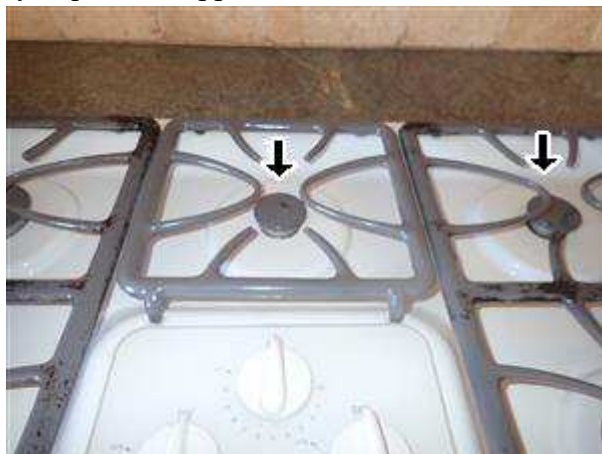
7.1 Picture 1

Two of the igniters in the cooktop did not operate when tested. Recommend repair by a qualified appliance technician.

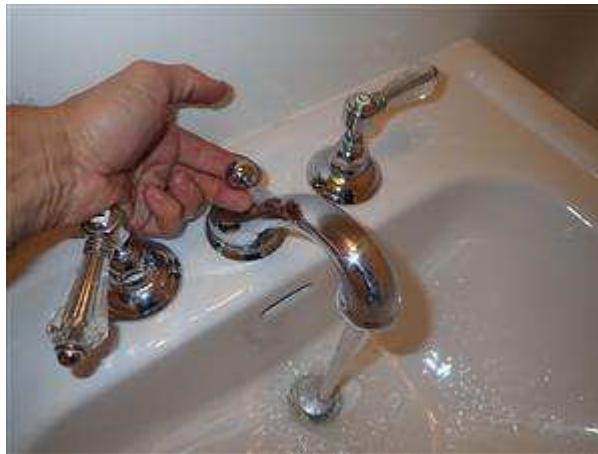
8.0 Picture 1

(1) The drain stopper in the half bathroom sink does not operate. Recommend adjusting or replacing the drain stopper linkage.

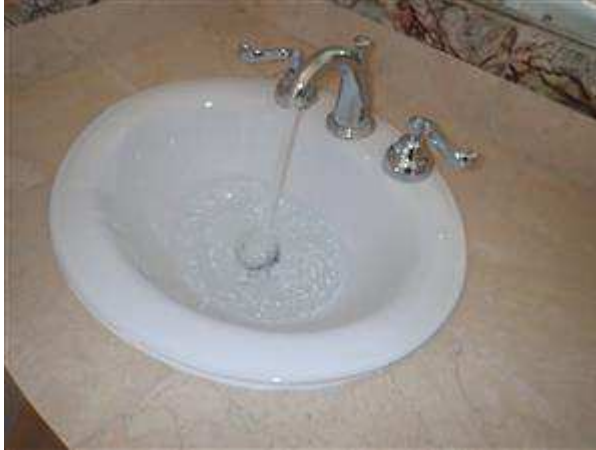
8.0 Picture 2

(2) The west master sink is slow to drain. Recommend removing the drain screen and testing to determine if further corrective action is necessary.

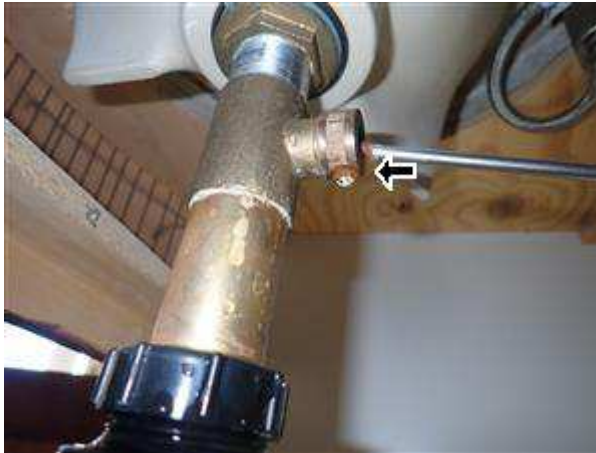
8.0 Picture 3

(3) A leak was detected at the west master sink drain. Recommend repair by a qualified person.

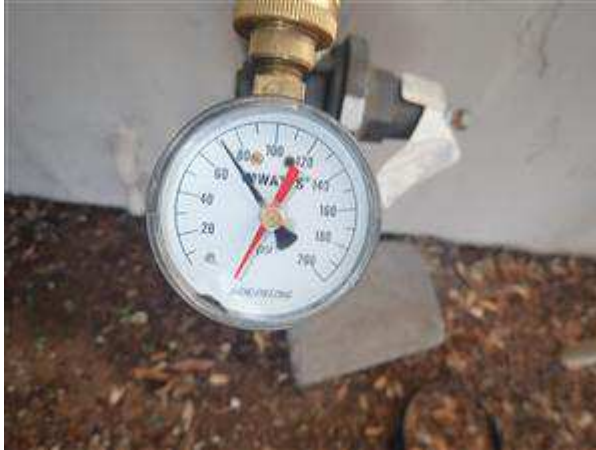
8.1 Picture 1

(1) The water pressure at the home was about 70 PSI which is within the recommended pressure of 40-80 PSI.

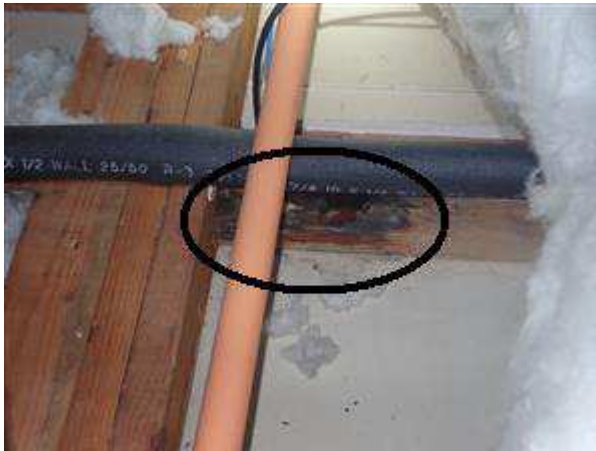
8.1 Picture 2

(3) A leak was detected below an insulated copper supply pipe in the attic (adjacent to the whole house fan). Recommend further evaluation from a licensed plumber and repair as necessary.

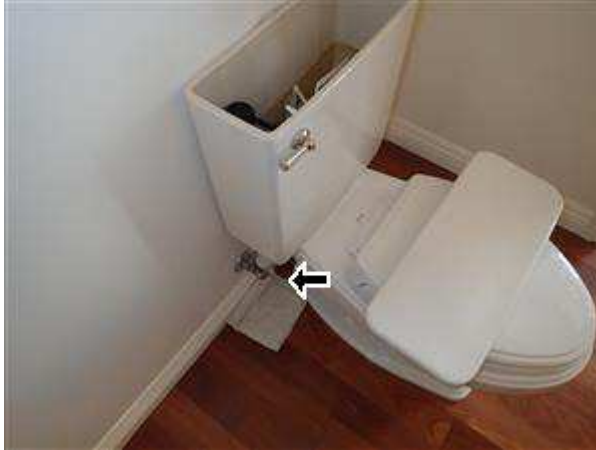
8.1 Picture 3 Half bathroom

(4) Some of the angle stops in the home are closed for the toilets and hot water to the kitchen island sink. Inspectors do not open angle stops. Recommend opening the angle stops and testing to determine if corrective action is necessary.

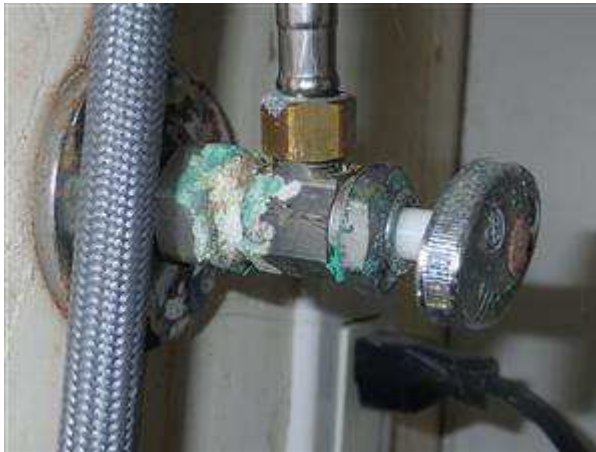
8.1 Picture 4 Kitchen

(5) Some of the angle stops were corroding and may have a limited servicable life remaining. Recommend further evaluation from a licensed plumber and replace as necessary.

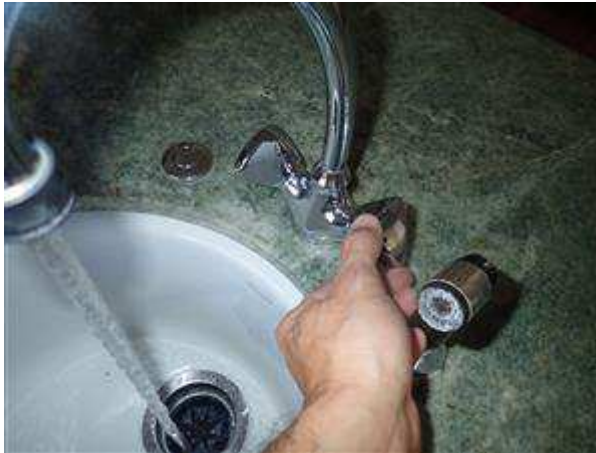
8.1 Picture 7

(6) The cold water valve for the kitchen island sink turns 360 degrees without a stopping point. Recommend repair or replacing the faucet by a licensed plumber.

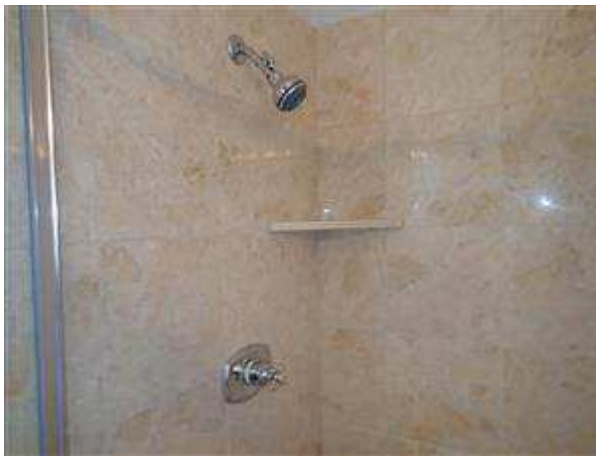
8.1 Picture 9

(7) Water is not available from the upper level hall bathroom shower valve or bathtub valve. Recommend further evaluation from a licensed plumber and repair as necessary.

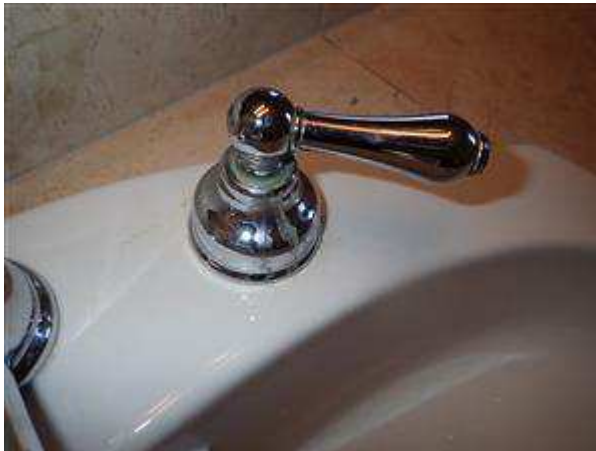
8.1 Picture 10

(8) The cold water valve at the upper level hall bathroom sink leaks when it is opened. Recommend further evaluation from a licensed plumber and repair or replace as necessary.

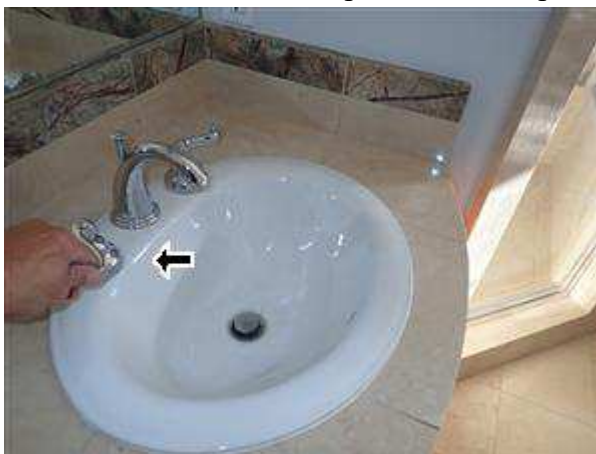
8.1 Picture 11

(9) The hot water valve at the east master sink is seized. Recommend further evaluation from a licensed plumber and repair or replace as necessary.

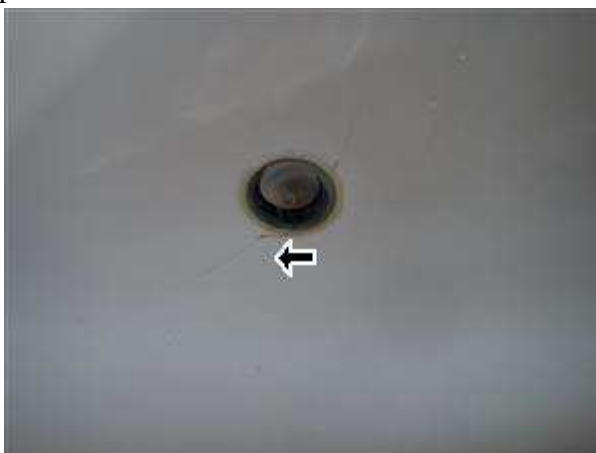
8.1 Picture 12

(10) The east master sink is cracked. Recommend replacing the sink by a licensed plumber.

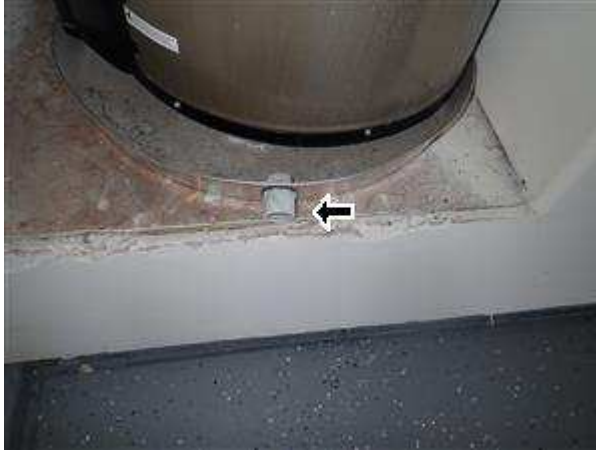
8.2 Picture 1

(2) Recommend installing a drain from the hot water tank drip pan to the garage floor.

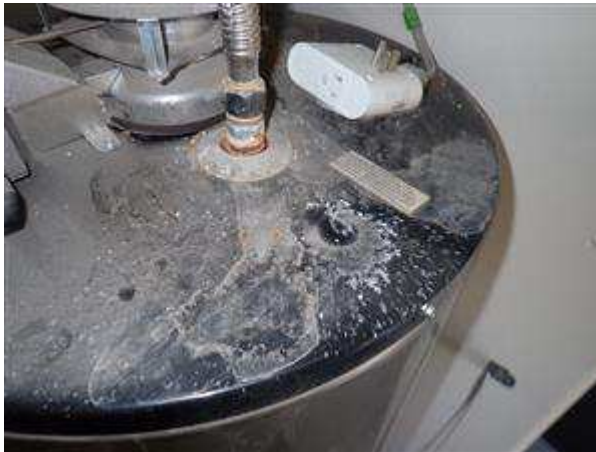
8.2 Picture 2

(3) Evidence of a previous leak was observed on top of the hot water tank. Recommend further evaluation from a licensed plumber to determine if corrective action is necessary.

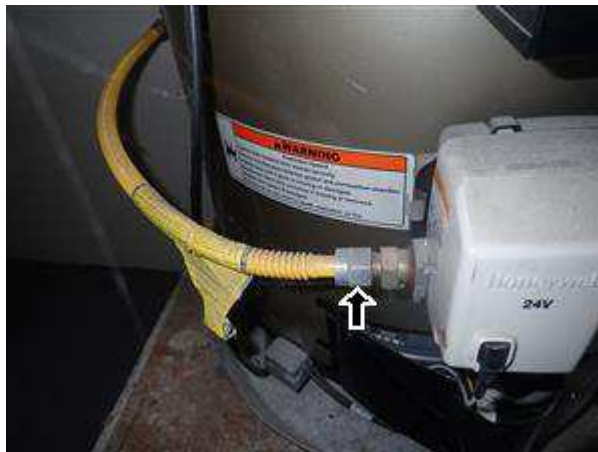
8.2 Picture 3

(4) A sediment trap was not installed for the gas line entering the hot water tank which would not meet current industry standards. Recommend installing a sediment trap by a licensed plumber.

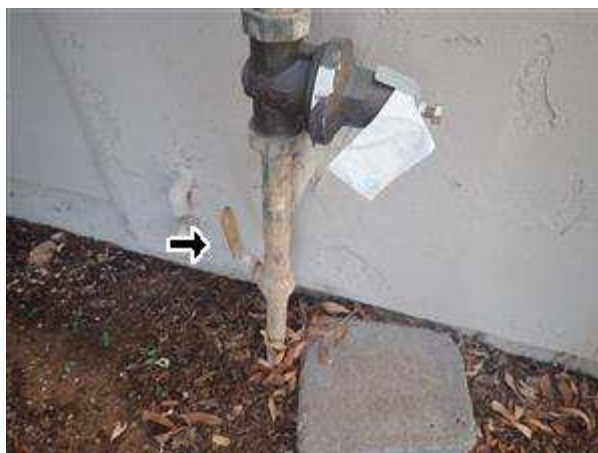
8.3 Picture 1

The main water shut off is located outside on the south side of the garage.

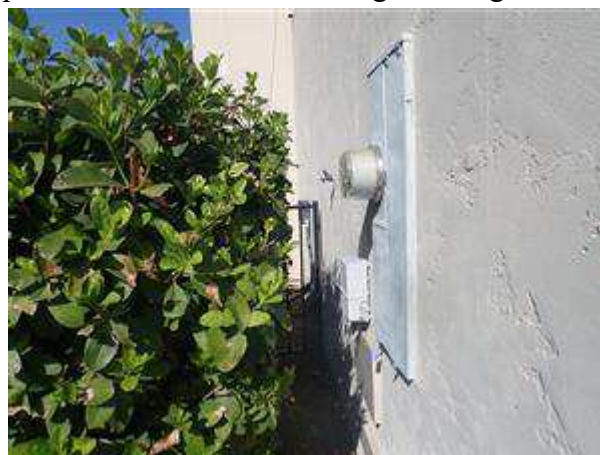
9.0 Picture 1

(1) The hedge in front of the electrical panel does not provide proper access to the panel. Recommend removing the hedge.

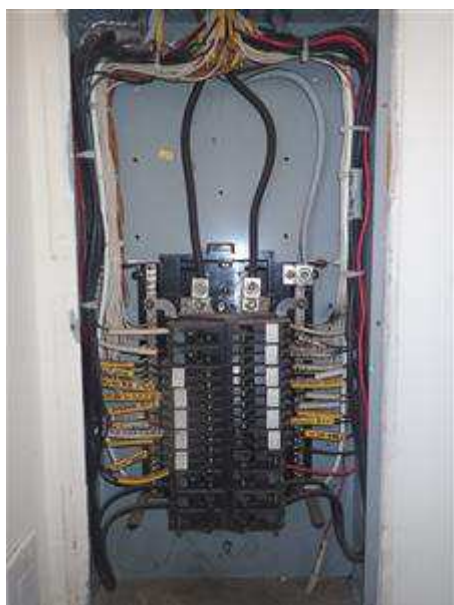
9.0 Picture 3

(3) Photo of the sub panel (located in the garage utility closet) with the service cover removed.

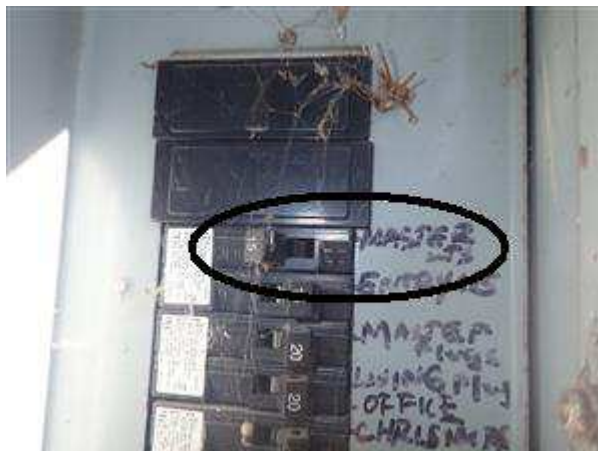
9.1 Picture 1 main electrical panel

immediately tripped suggesting an electrical short. Recommend turning on all breakers that are off, testing the circuits/lights and further evaluation by a licensed electrician to determine what corrective action is necessary.

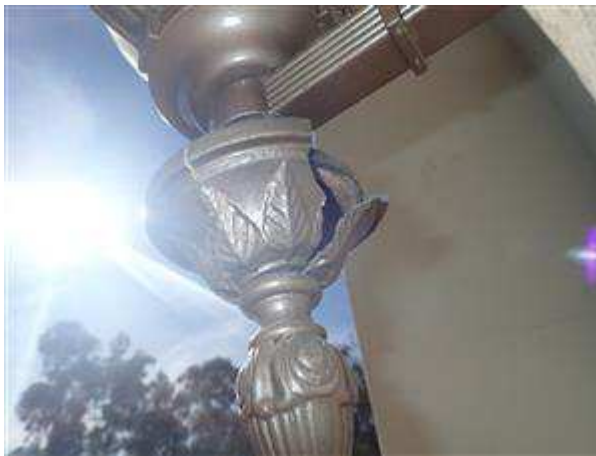
9.2 Picture 2

(1) The exterior light fixtures at the west side of the home and on both sides of the main entry door are damaged. Recommend replacing the damaged fixtures by a qualified person.

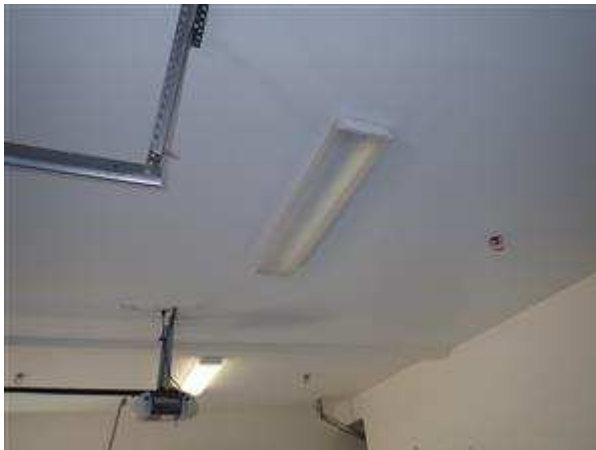
9.2 Picture 3

(2) One of the garage light fixtures did not operate. Recommend changing the bulbs and testing to determine if further corrective action is necessary.

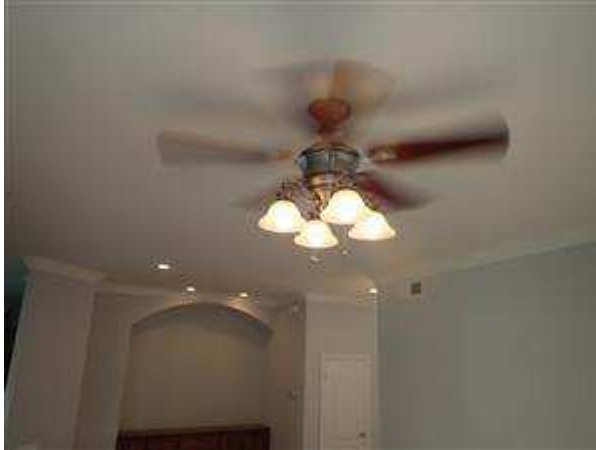
9.2 Picture 4

(4) The family room ceiling fan and master study fan are somewhat noisy in the opinion of the inspector.

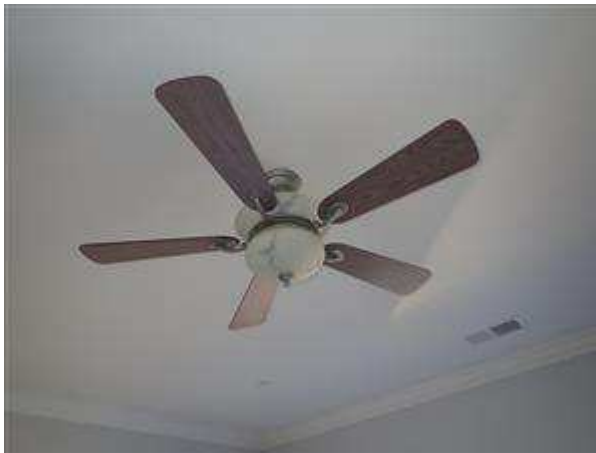
9.2 Picture 5

(5) The master bedroom ceiling fan did not operate. Recommend determining if power is available or if a remote is missing.

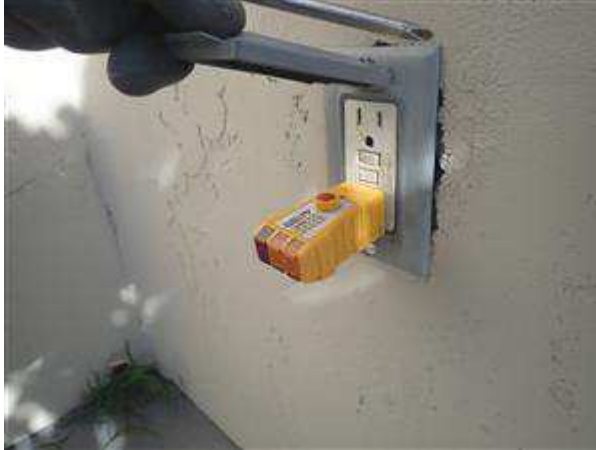
9.4 Picture 1

(1) The south exterior GFCI receptacle did not trip when tested. Recommend replacing the GFCI receptacle by a qualified person.

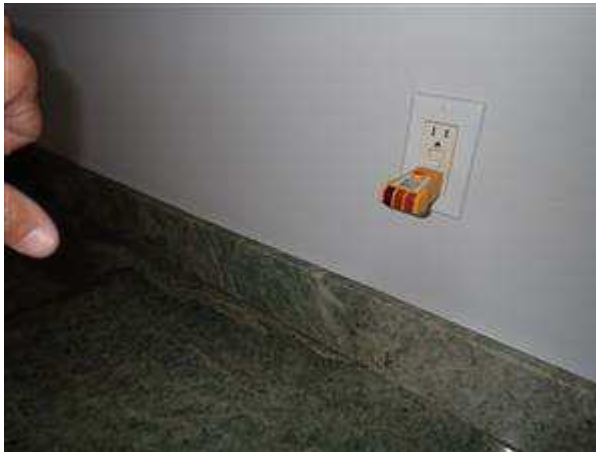
9.4 Picture 2

(2) Receptacles at the east side of the kitchen did not have power and the GFCI receptacle did not reset. Recommend further evaluation from a licensed electrician to determine what corrective action is necessary.

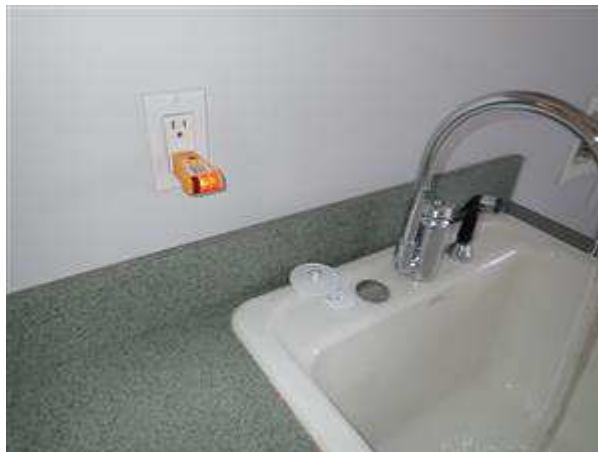
9.4 Picture 3

(3) The receptacle adjacent to the laundry sink is not GFCI protected which does not meet industry standards. Recommend installing a GFCI receptacle by a qualified person.

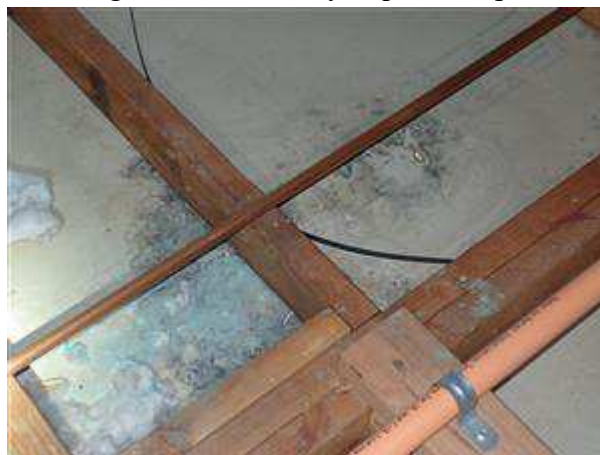
10.0 Picture 1

(1) Stains and a mold like substance were observed on the upper level hallway ceiling from the attic. Recommend asking the seller for any leak history and removing the substance by a qualified professional.

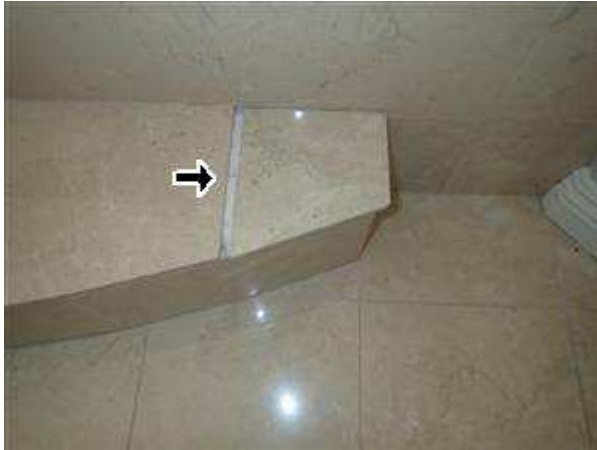
10.2 Picture 1

(1) Some of the floor tiles in the master bathroom were not properly secured and may become loose or crack over time. One tile at the bathtub step is not secure. Recommend securing the tile by a qualified person.

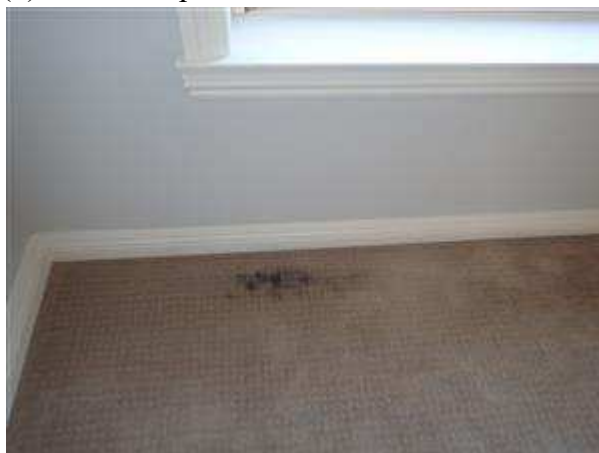
10.2 Picture 3

(4) Stains are present in the master bedroom and master closet carpet.

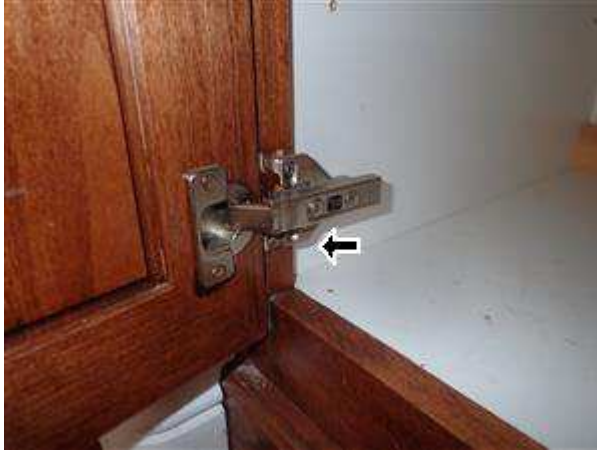
10.4 Picture 1

(1) The lower family room cabinet hinges are loose and missing screws. Recommend installing screws to secure the hinges.

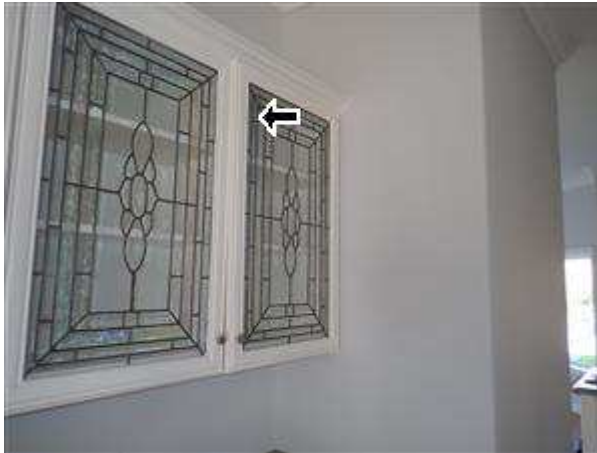
10.4 Picture 2

(2) The cabinet doors between the kitchen and dining room are out of alignment. Recommend adjusting the door hinges.

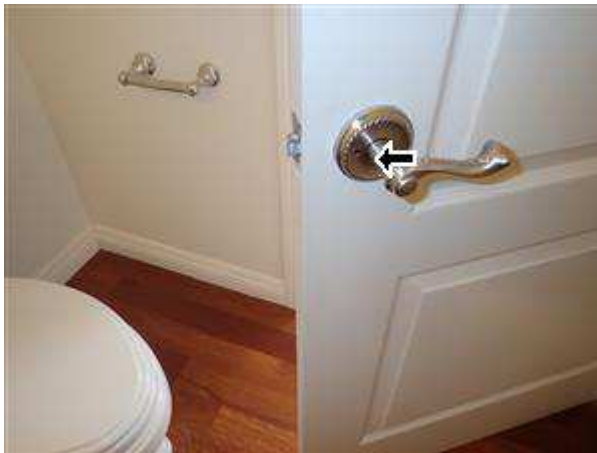
10.5 Picture 1 half bathroom

(1) The half bathroom and upper level hall bathroom doors are missing locking hardware. Recommend installing locking hardware or replacing the door knobs if privacy is desired.

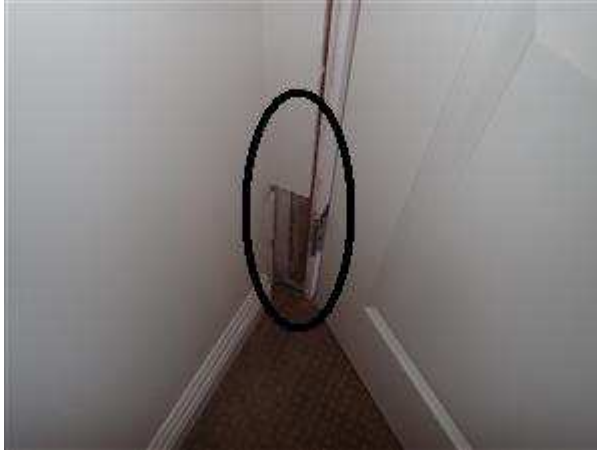
10.5 Picture 2

(2) Trim and drywall is missing behind the NE bedroom closet door.

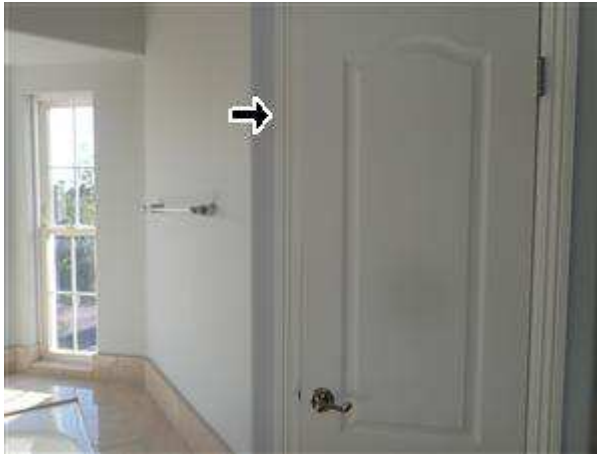
10.5 Picture 3

(3) The master water closet door comes in contact with it's jamb when closed. Recommend adjusting door and/or hardware.

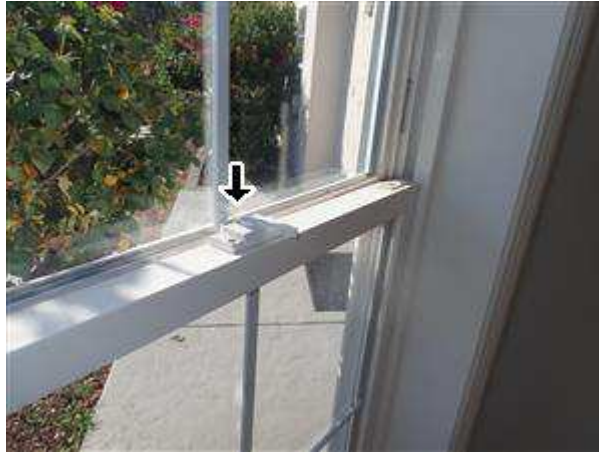
10.6 Picture 1

(1) The inspector was unable to lock the right locking device at the SW living room window. Recommend adjusting the locking mechanism by a qualified person.

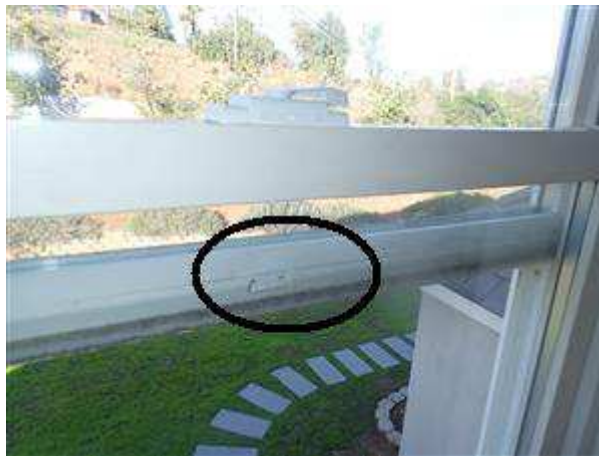
10.6 Picture 2

(2) The NE bedroom window is missing locking hardware. Recommend installing hardware to lock the window.

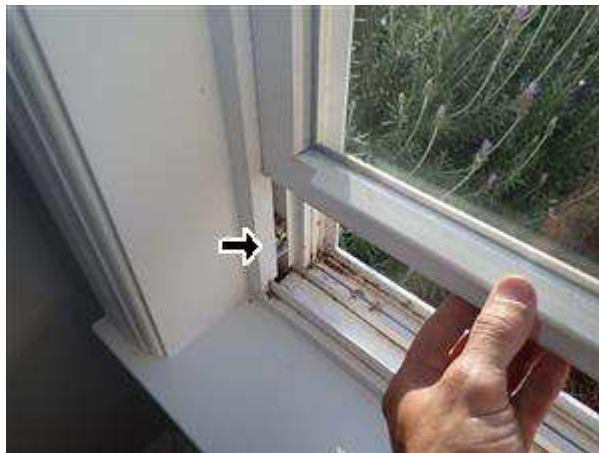
(3) The south family room window has separated from the window track. Recommend repairing the window by a qualified professional.
